Construction Specifications And Analysis Of Rehabilitation Techniques Of Pervious Concrete Pavement

Craig Ballock
University of Central Florida

A thesis submitted in partial fulfillment of the requirements
for the degree of Master of Science
in the Department of Civil and Environmental Engineering
in the College of Engineering and Computer Science
at the University of Central Florida
Orlando, Florida

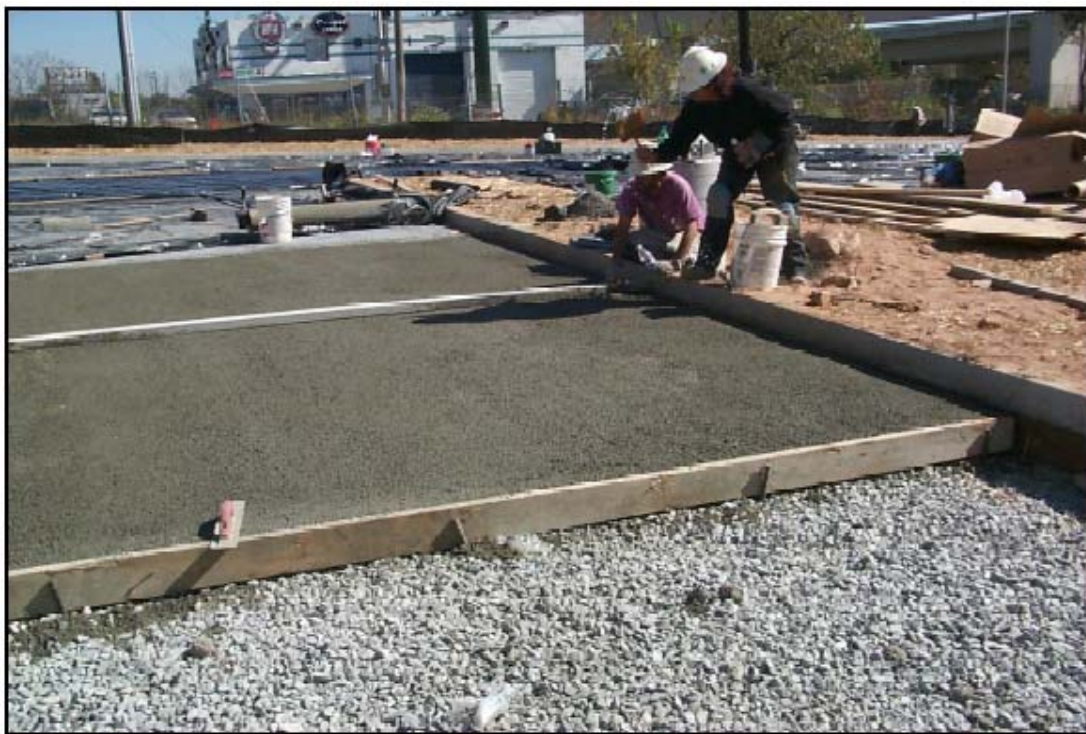
Figure 2: Typical Porous Concrete Installation

infiltration is to be relied on to remove the stored water volume. (EPA, 1999) Figure 2 shows a typical porous concrete installation.

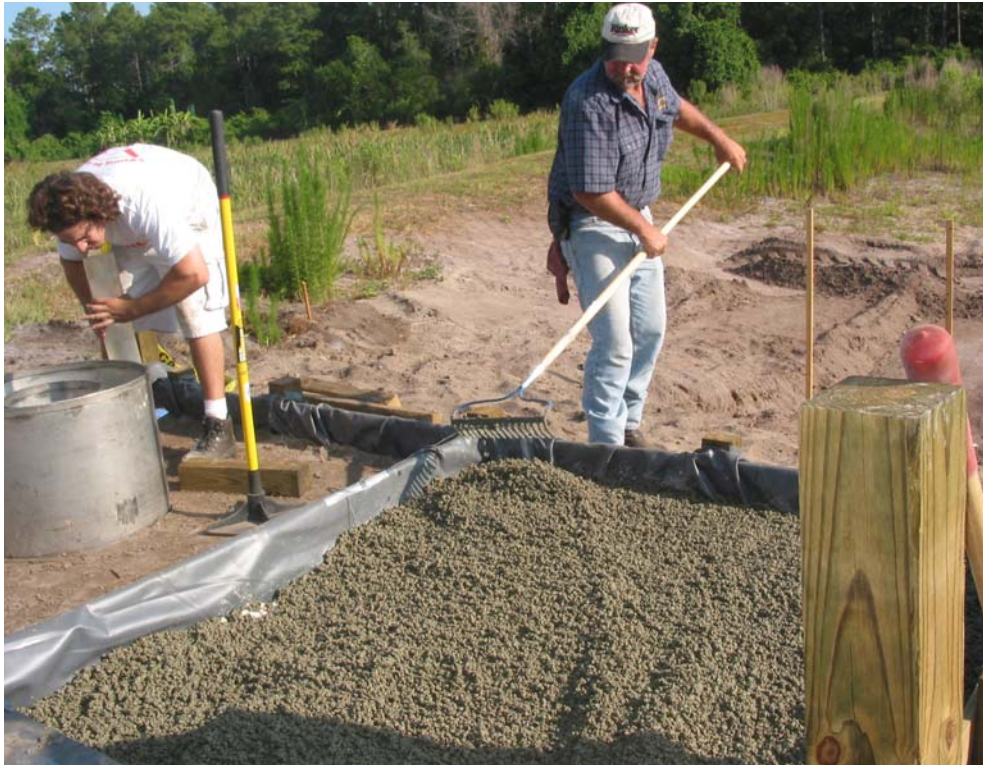
Figure 3: Stormwater Academy Porous Concrete Test Cell Installation

One cell contains a 5 inch deep reservoir of $\frac{3}{8}$ to $\frac{1}{2}$ inch coarse aggregate, and both cells have a 5- inch thick pervious concrete slab. Depicted in Figure 3 is the installation of the pervious concrete in the test cells as well as a double-ring infiltrometer test being performed on the compacted subsoil.

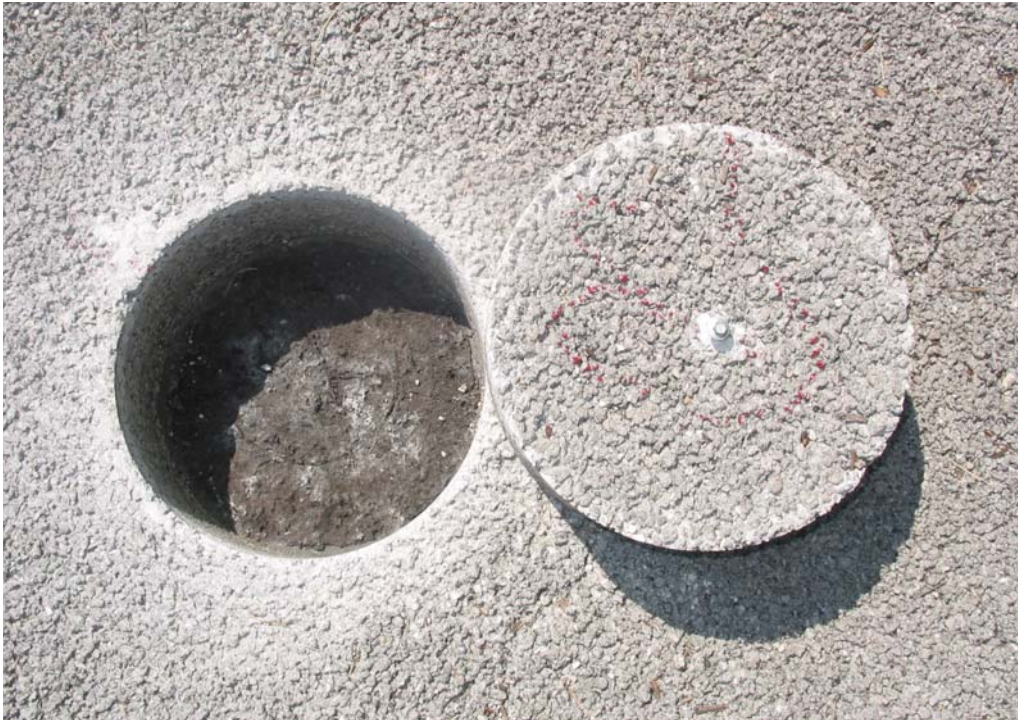
Figure 8: Pervious Concrete Pavement Core

The core samples are left in place after drilling for in-situ infiltration testing. When necessary, the cores were extracted and grinded along the sides to remove irregularities formed during the coring process to allow the single-ring infiltrometer to fit around the core. A four-inch angle grinder with a masonry disk was utilized for this task. Figure 8 shows the 12 inch core placed next to the location it was removed from in the pavement. It is clear that the pavement system at this site does not have a drainage layer of gravel. This configuration is typical for pavements on soils with high permeability values.

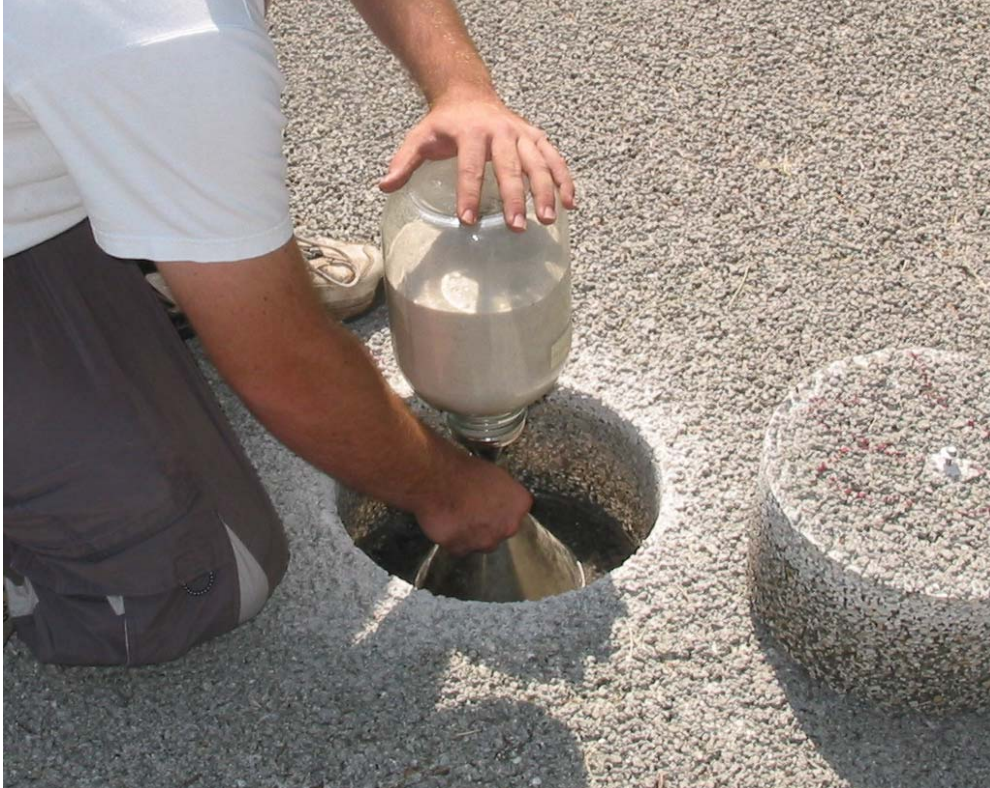
Figure 10: Performing Sand Cone Test

7. The field unit weight of the subsoil is then determined using the Sand Cone Method as outlined in ASTM D 1556 “Standard Test Method for Density and Unit Weight of Soil in Place by the Sand-Cone Method”. Figure 10 shows a sand cone test in progress.

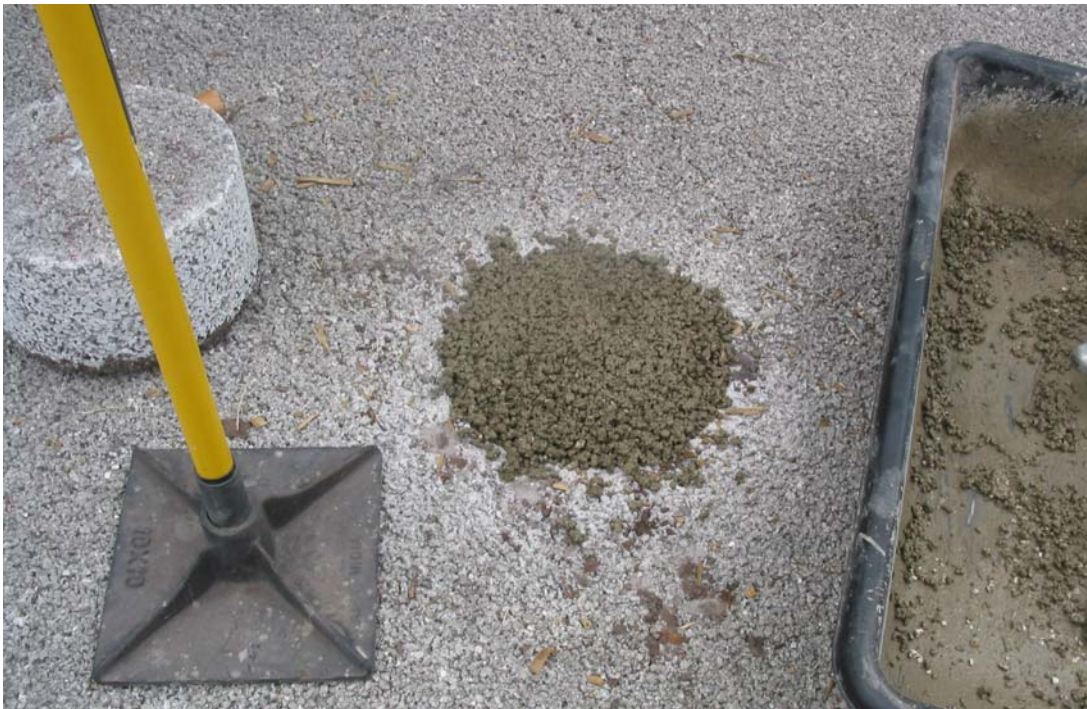
Figure 11: Repair of Concrete Core Area

9. Water table depths are recorded for use in modeling studies planned for the pervious concrete system.
10. The subsoil shall be replaced and the pervious concrete is repaired using the original specifications at the locations where it was cored. An example of this patching is depicted in Figure 11.

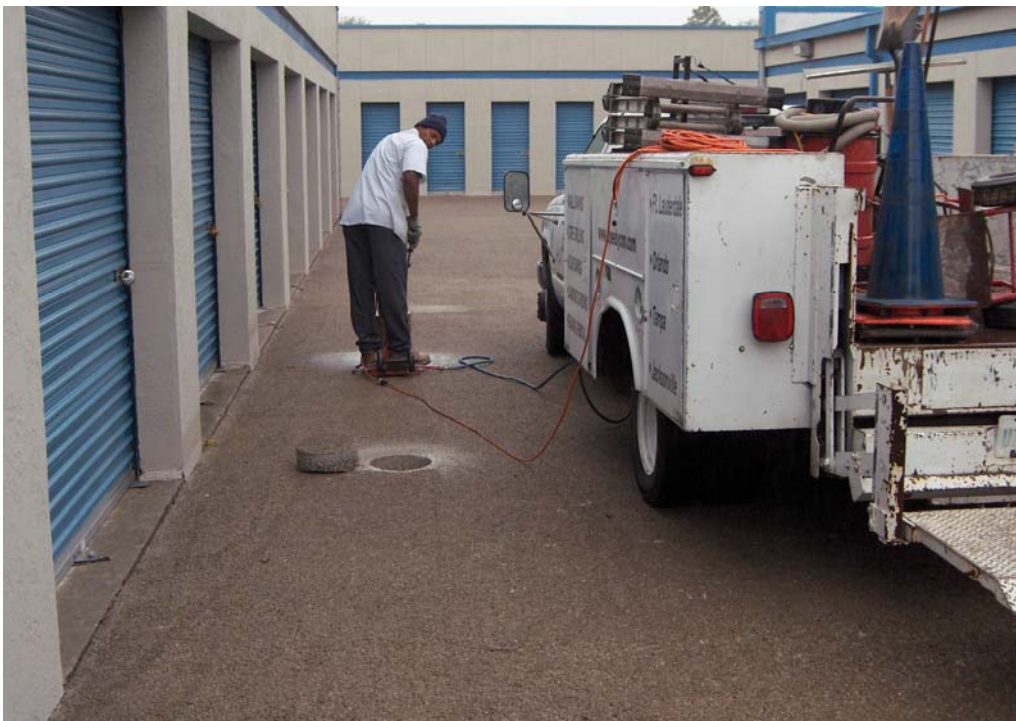
Figure 16: Sun Ray Store-Away Pervious Pavement at Core Locations 1, 2 & 3

infiltration rates measured in the laboratory that ranged from 627 to 3 in/hr. Instances where the system infiltration rates are higher than the individual core infiltration rates measured in the lab is due to infiltration along the sidewall of the cores that occurred in the field but was restricted in the lab producing false high infiltration rates in the field. The cores performed in the area of cores 1, 2 and 3 exhibited higher infiltration rates than other areas. This result was anticipated as the pervious concrete surface in that area was in a visually better condition; this area is shown in Figure 16.

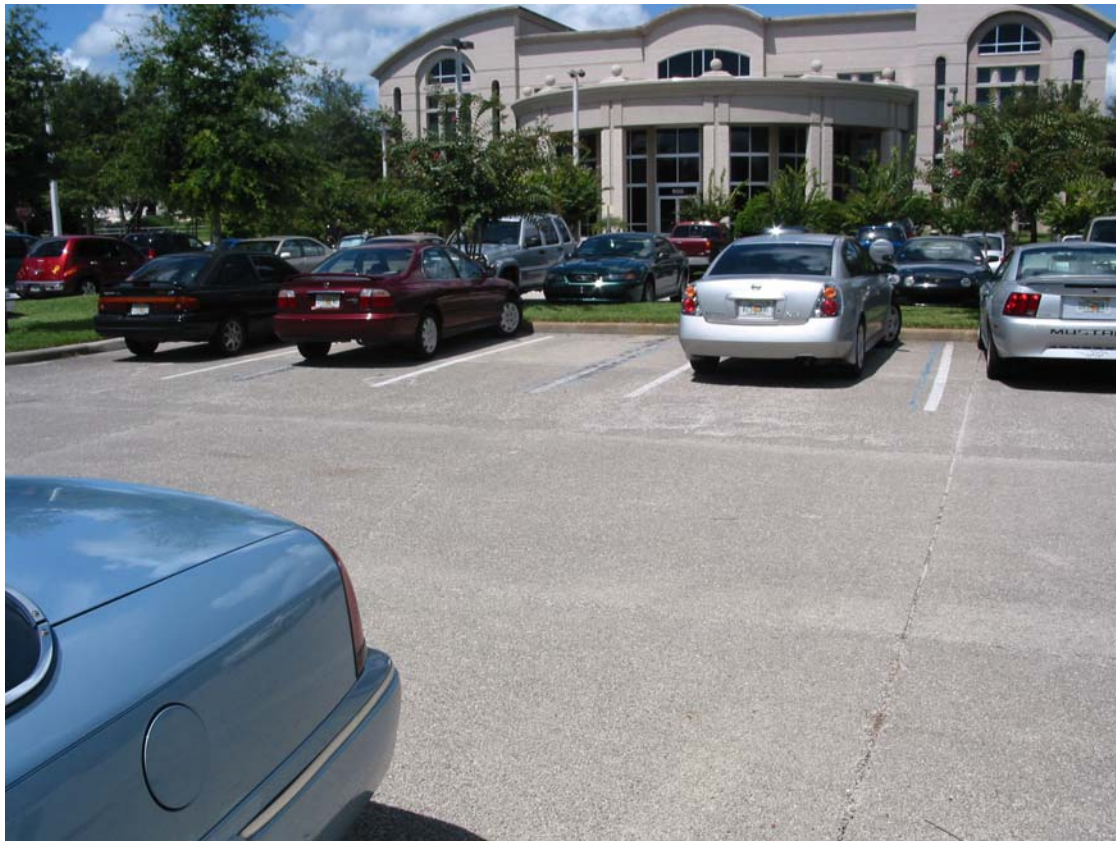
Figure 18: Strang Communication Office Photograph

This pervious parking lot exhibited minimal damage to the surface, although, significant raveling has taken place in one location on the site. Raveling is the deterioration of the concrete due to repeated loads over time on an area. The 9 spaces located in the northwest area of the pervious concrete are raveling at the entrance to each stall. As these spaces are located closest to the building, they would be typically be subjected to the most traffic loading. Also, a small amount of raveling at the entrance to the parking row on the west was also noted. Algae and leaf debris staining are also present over a majority of the pervious concrete parking lot. Figure 17 shows the location of the raveling and algae in this parking area. Depicted in Figure 18 is a picture of this site.

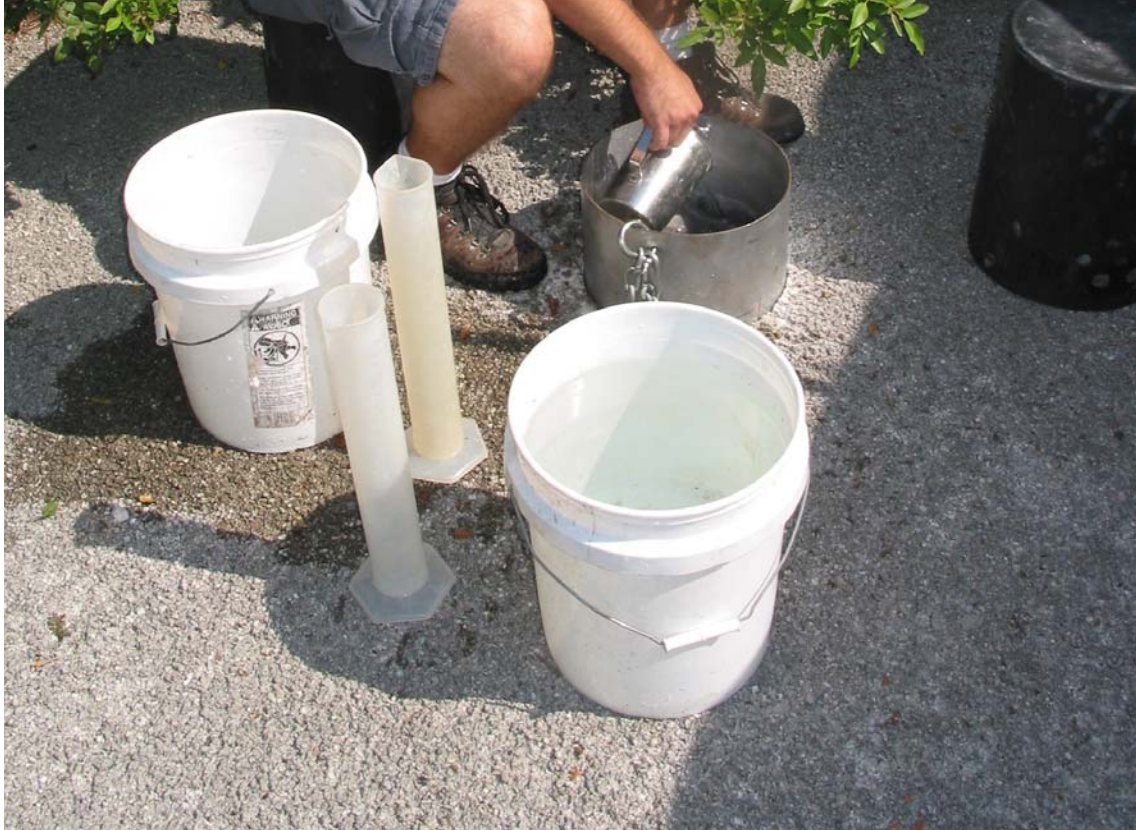
Figure 20: Murphy Veterinarian Clinic Photograph

result indicates that the pervious concrete surface is acting as the limiting factor at this pervious concrete installation. Figure 20 depicts a subsoil infiltration test being performed at the test.

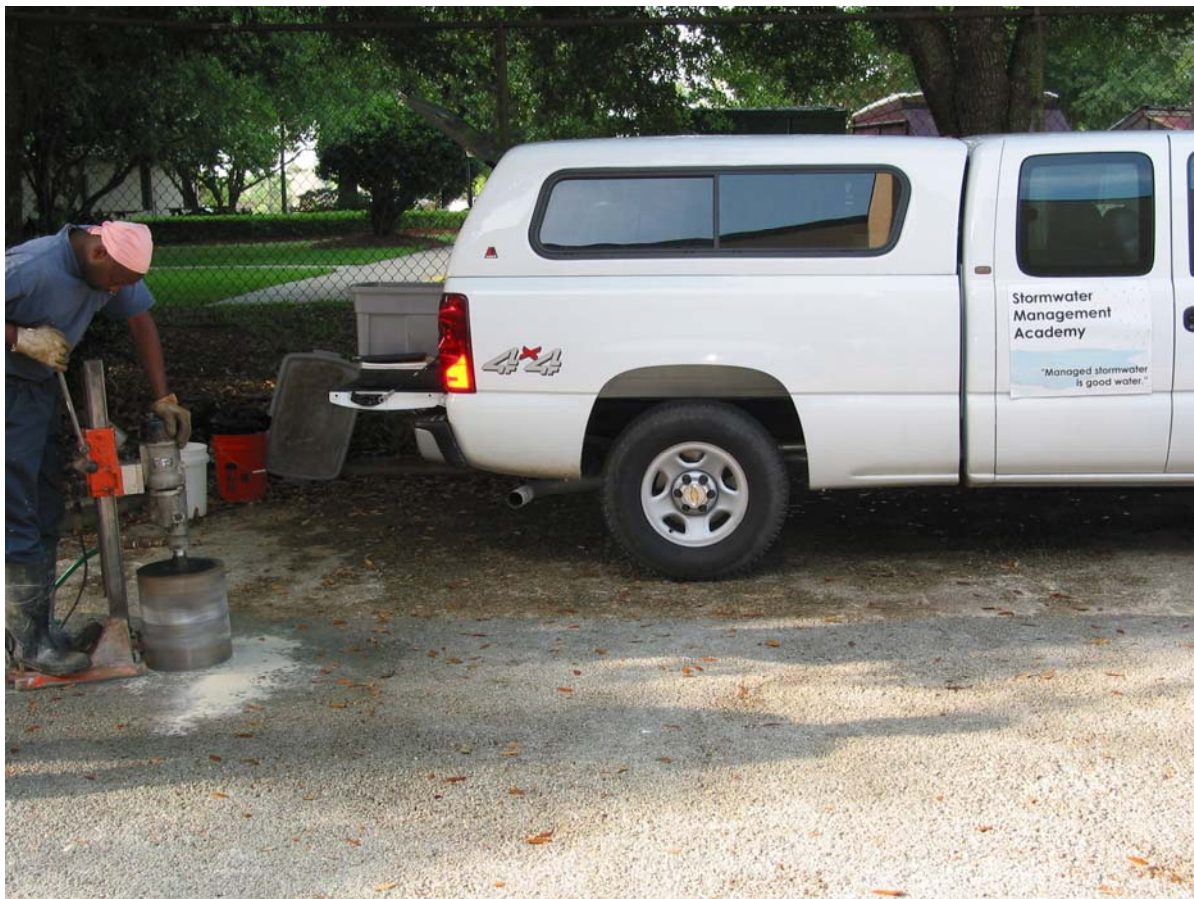
Figure 22: FDEP Parking Lot Photograph

ranged from 0 to 5.2 in/hr. The cores performed in the area of cores 4, 5 and 6 exhibited higher infiltration rates than other areas. This result was anticipated as the condition of the pervious concrete surface in the other areas was compromised due to poor construction practices. Higher than typical unit weights are also indicative of poor construction practices. Low infiltration rates of the subsoil in the areas of Cores 4 through 6 was due to a layer of poorly draining, orange clay encountered directly beneath the pervious concrete. Figure 22 depicts the coring operation performed at this site.

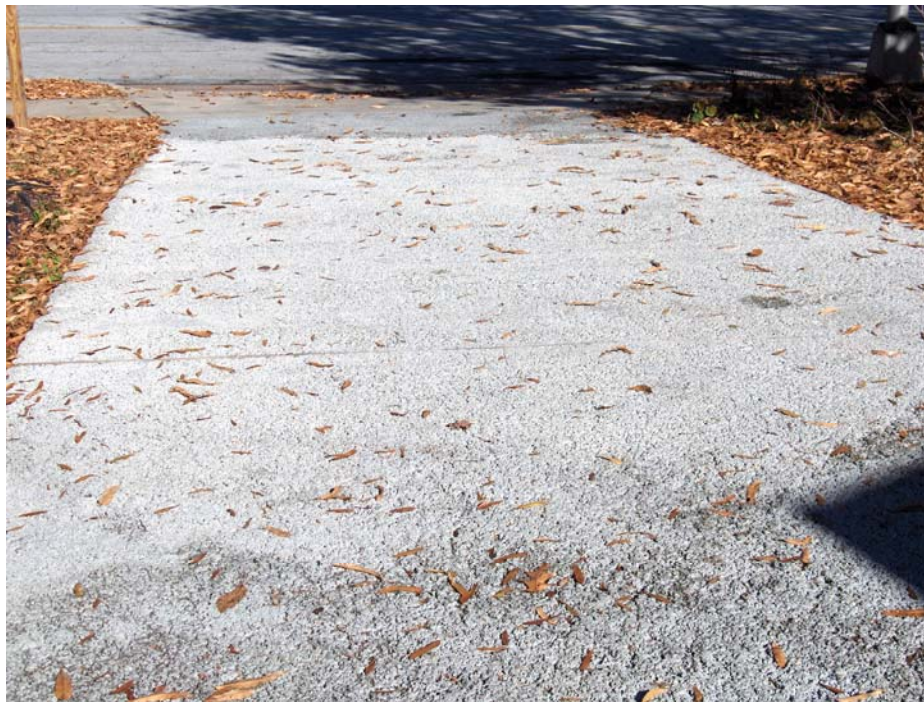
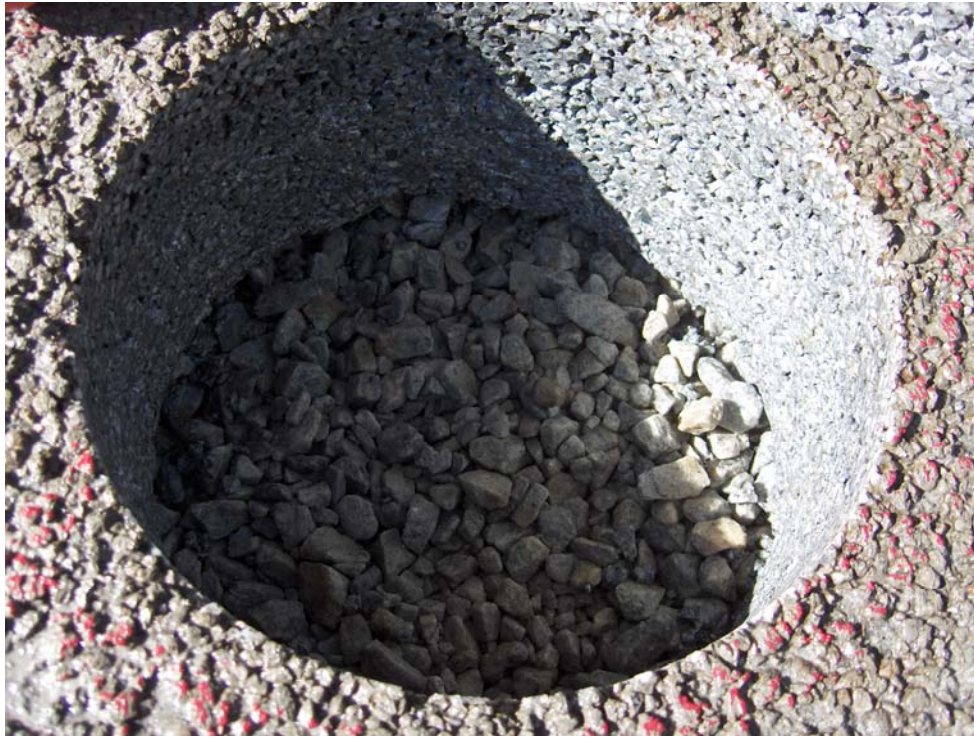
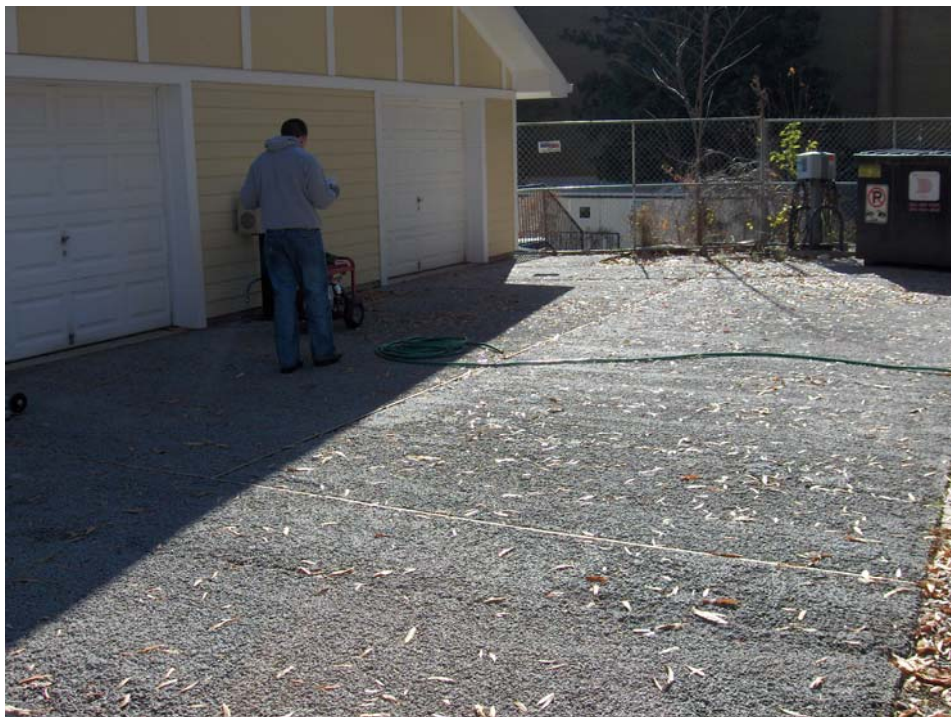
188 in/hr. This wide range of infiltration rates can be contributed to varying surficial pore sizes and unit weights in pervious concrete due to poor construction techniques. Field system infiltration rates were not measured due to the presence of a gravel reservoir, which the single-ring infiltrometer is unable to penetrate. These results indicate that the subsoil is acting as the limiting factor at this pervious concrete installation, however a gravel reservoir has added storage to the site to allow a longer recharge time. Laboratory tests indicate the gravel reservoir has a porosity of approximately 0.32 or a storage capacity of approximately 2 inches of water. Photographs depicting the condition of the pervious concrete in this area are shown in Figures 26, 27 and 28.

Figure 26: Southface Institute Parking Lot Photograph

Figure 27: Southface Institute Gravel Subbase Photograph

Figure 28: Southface Institute Parking Lot 2 Photograph

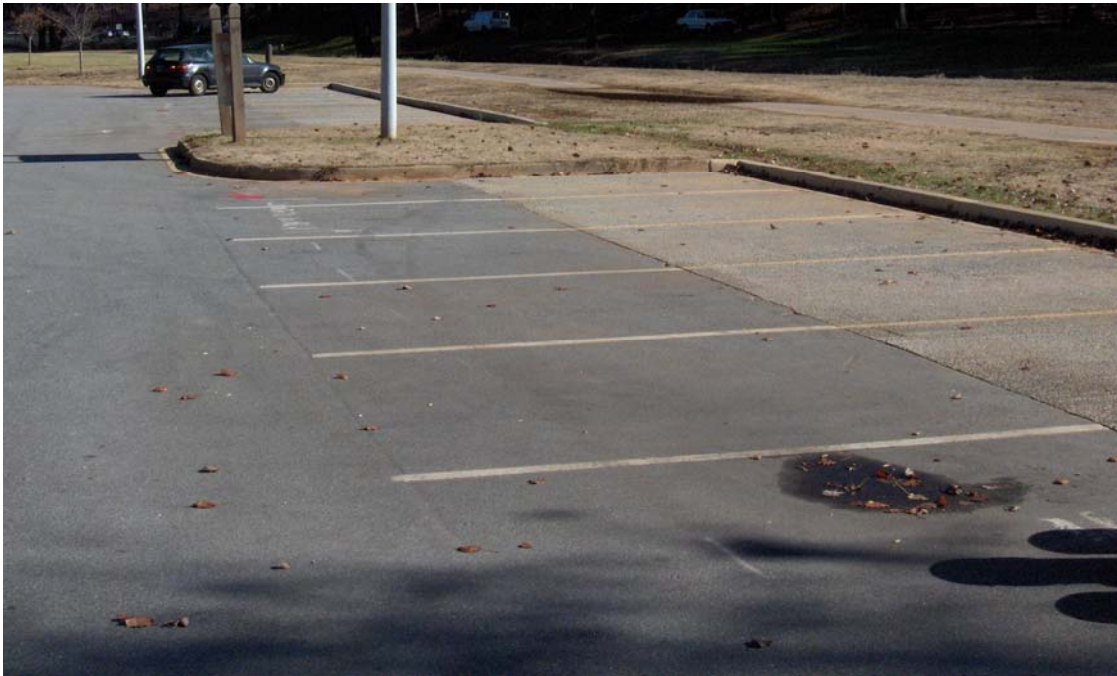
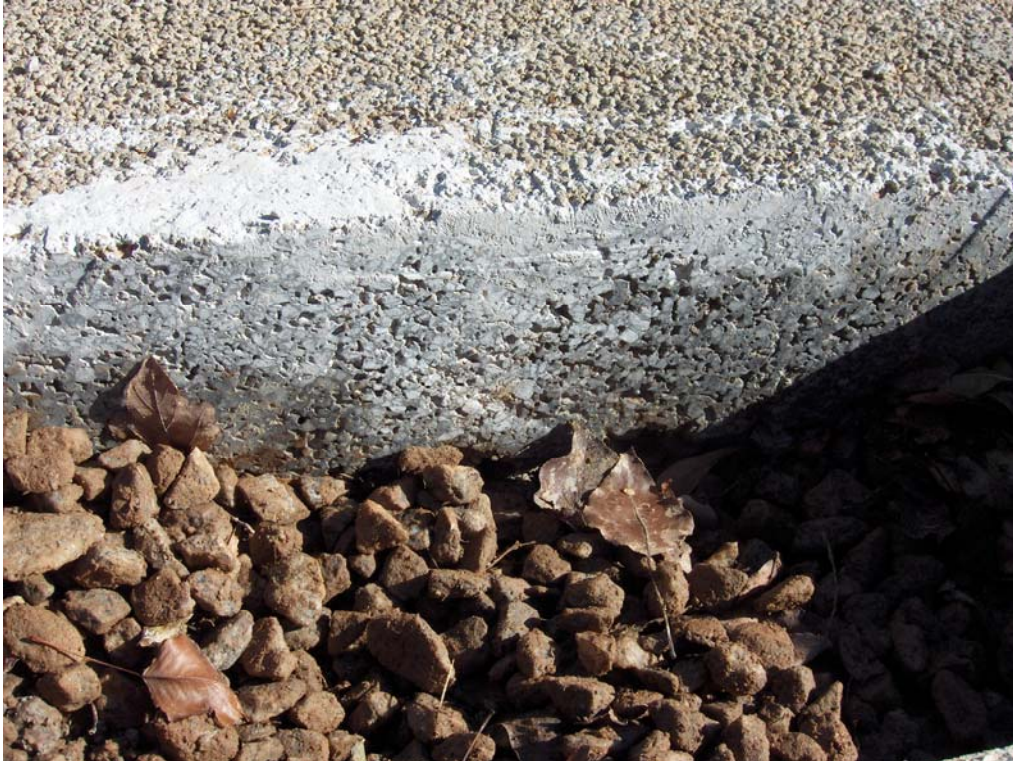
zero that was measured was due to a lack of voids present in the concrete due to poor construction techniques as verified by the comparatively high unit weight of the core. Field system infiltration rates were not measured due to the presence of a gravel reservoir, which the single-ring infiltrometer is unable to penetrate. These results indicate that the subsoil is acting as the limiting factor at this pervious concrete installation, however, a gravel reservoir has added storage to the site to allow a longer recharge time. Laboratory tests indicate the gravel reservoir has a porosity of approximately 0.32 or a storage capacity of approximately 2 inches of water. Photographs depicting the condition of the pervious concrete in this area are shown in Figures 30, 31 and 32.

Figure 30: Cleveland Park Parking Lot Photograph

Figure 31: Cleveland Park Parking Lot Pavement Photograph

Figure 32: Cleveland Park Parking Lot Reservoir Photograph

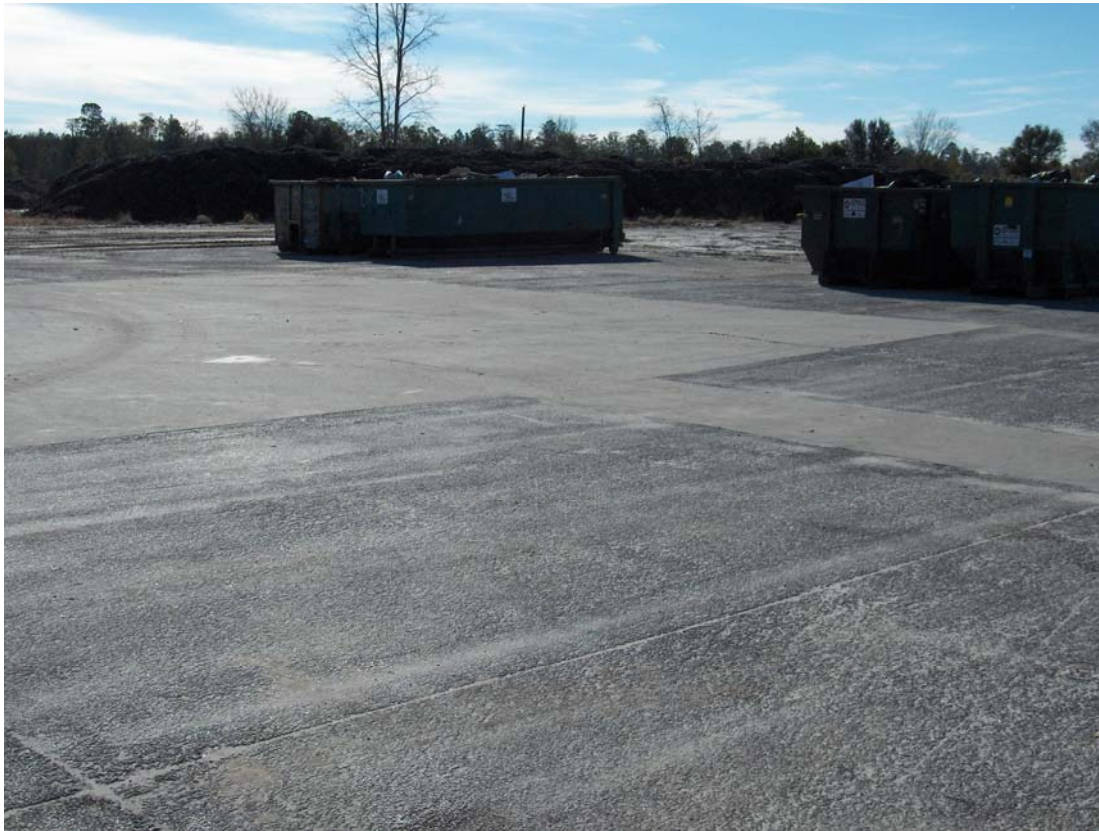
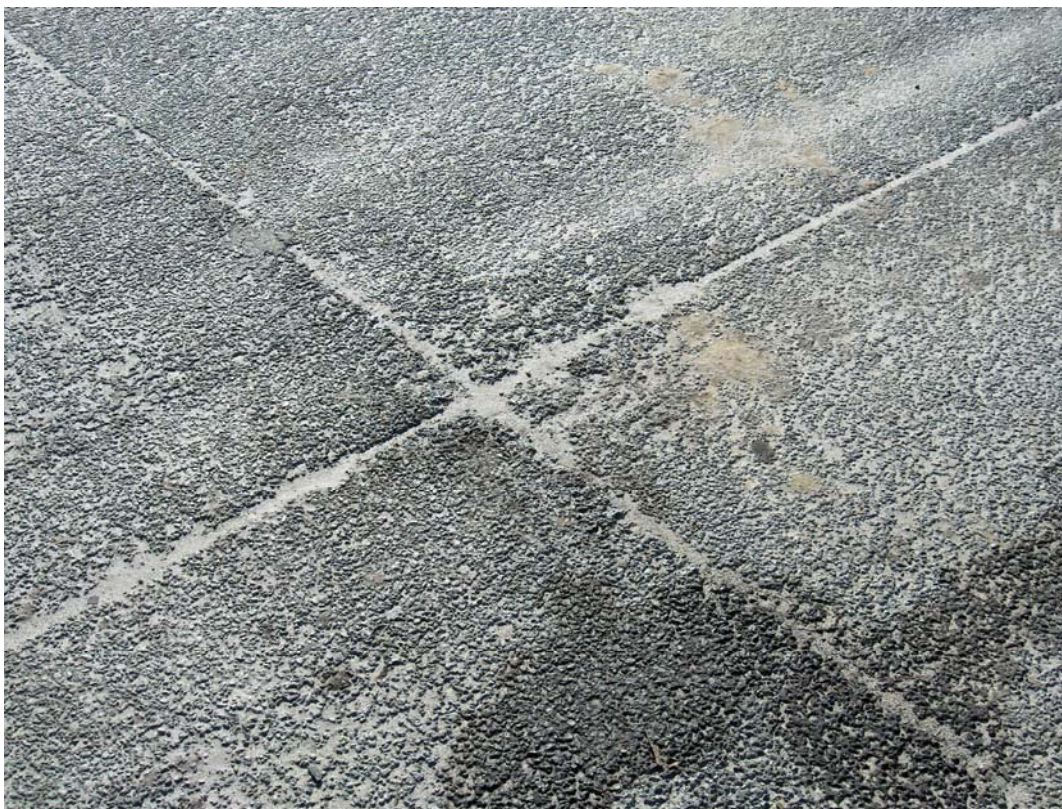
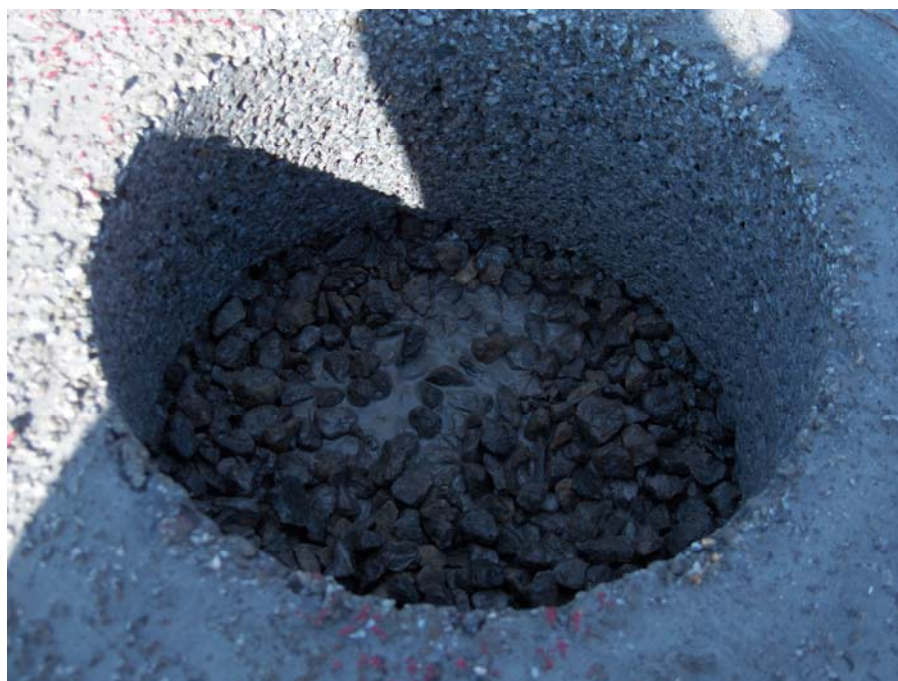
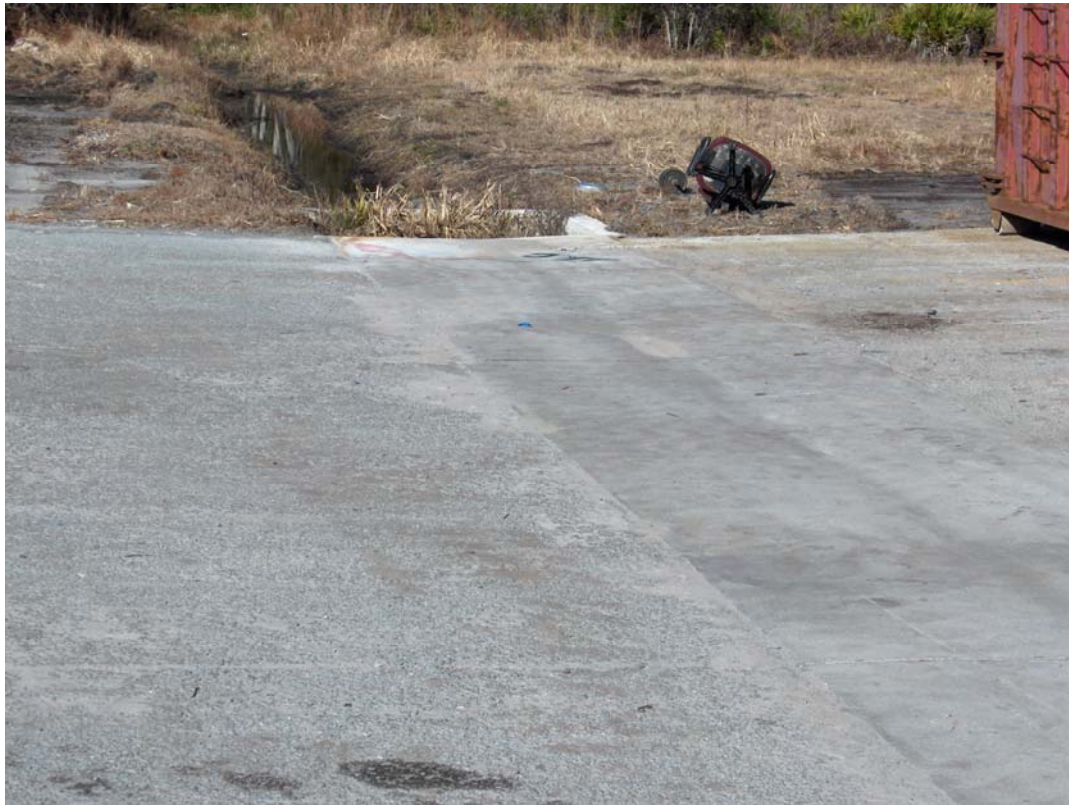
be contributed to varying surficial pore sizes in pervious concrete due to poor construction techniques. Field system infiltration rates were not measured due to the presence of a gravel reservoir, which the single-ring infiltrometer is unable to penetrate. These results indicate that the subsoil is acting as the limiting factor at this pervious concrete installation, however, a gravel reservoir has added storage to the site to allow a longer recharge time. Laboratory tests indicate the gravel reservoir has a porosity of approximately 0.32 or a storage capacity of approximately 2 inches of water. Photographs depicting the condition of the pervious concrete in this area are shown in Figures 34, 35, 36 and 37.

Figure 34: Effingham County Landfill Photograph

Figure 35: Effingham County Landfill Pervious Pavement Photograph

Figure 36: Effingham County Landfill Reservoir Photograph

Figure 377: Effingham County Landfill Ditch Photograph

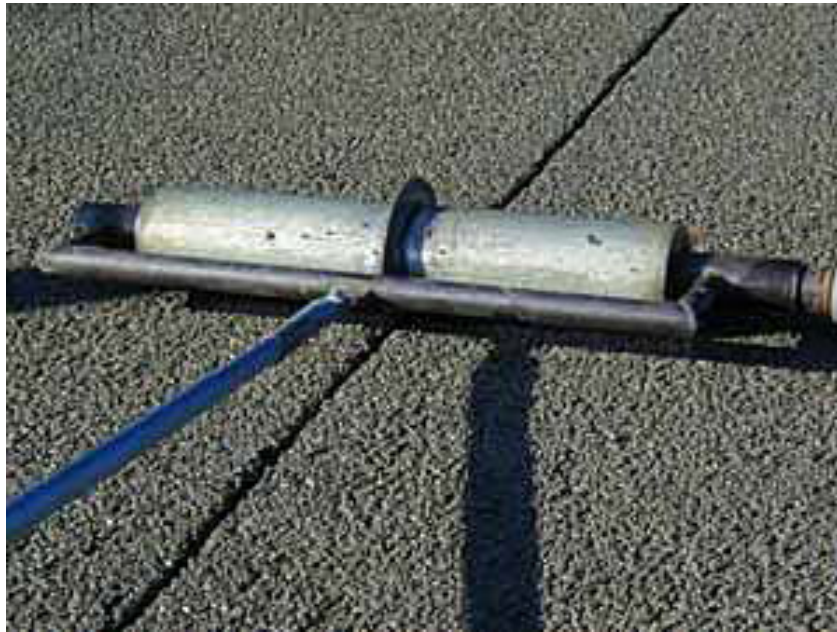
Figure 44: Roller Used to Create Joints in Pervious Concrete

Longitudinal control joints shall be constructed at the midpoint of the travel lanes if the lane width exceeds 15 feet. Construct transverse joints at a maximum 20 feet apart in travel lanes. The joints are to be installed in the plastic concrete by a roller with a flange welded to it, as depicted in Figure 44. The depth of the joints shall be $\frac{1}{4}$ of the pavement thickness but is not to exceed 1.5 inches.
